## **APPENDIX F2: Geohydrology Impact Assessment**

# **Geohydrological Assessment for Mossdustria, Mossel Bay, Western Cape**

*Water Use Licence Application for Mossel Bay Local  
Municipality on RE/8/225, Mossel Bay, Western  
Cape*

14 AUGUST 2026  
GEOSS Report No.: 2026/08-08

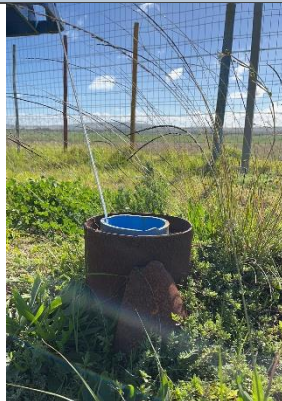
| Site ID | Water source | Latitude (DD, WGS84) | Longitude (DD, WGS84) | Depth (mbgl) | General comments | Water Level (mbgl) | Picture |
|---|---|---|---|---|---|---|---|
| HC_BH1 | Borehole | -34.179108 | 22.027788 | 150 | <p>Very smelly water. Borehole was drilled about 4 years ago and is not currently in use. Water quality and isotope samples were taken.</p> <p>EC = 1 005.4 mS/m<br/>TDS = &gt;6 000ppm<br/>pH = 7.0</p> | 7.16 | |

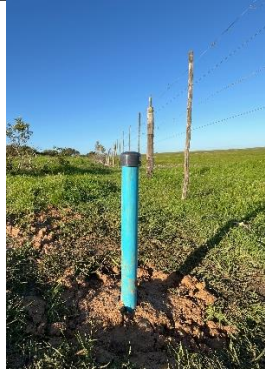
| Site ID | Water source | Latitude (DD, WGS84) | Longitude (DD, WGS84) | Depth (mbgl) | General comments | Water Level (mbgl) | Picture |
|---|---|---|---|---|---|---|---|
| PZ1 | Piezometer | -34.17151 | 22.001099 | 1.7 | Competent clay-rich muds interbedded with very fine sand. Refusal was reached at approximately 1.7 mbgl.<br>EC = 115 mS/m<br>TDS = 570 ppm<br>pH = 6.3 | 0.48 | |
